# Influence of communal waste waters discharge on local sea ecosystem

Milena Tadić<sup>1</sup> University of Montenegro, Faculty of Metallurgy and Technology, Montenegro Pavle Đurašković<sup>2</sup> Institute of Hydrometeorology and Seismology of Montenegro, Montenegro

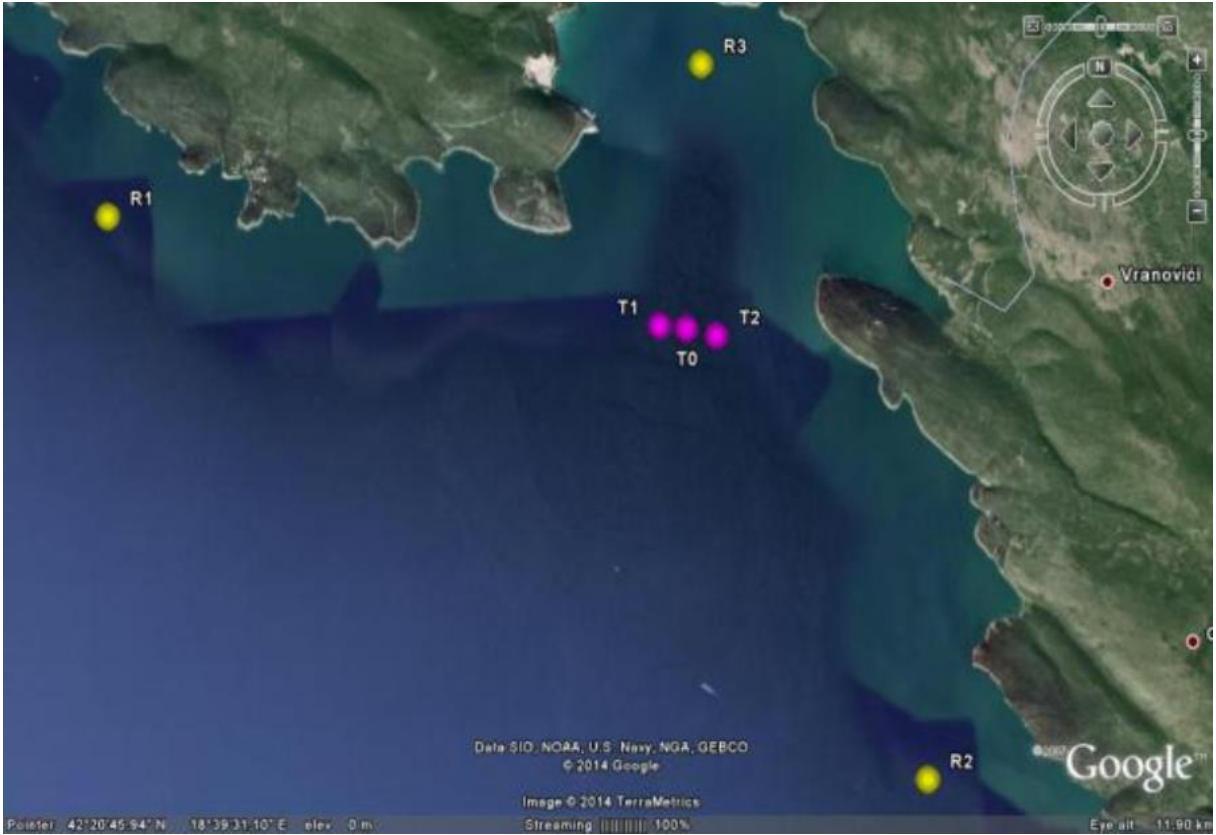
Figure 1. Network around outfall Trašte.

Measuring network at Trašte consisted of 6 stations: 3 points at transect close the end-of-pipe - T0, T1 and T2, control station toward Croatian coast - R1, control station toward Budva - R2, coastal station - R3 (Figure 1, Table 1).
